South East Queensland Floods 2011 Creeks, streambanks and paddocks Newsletter #2, March 2011

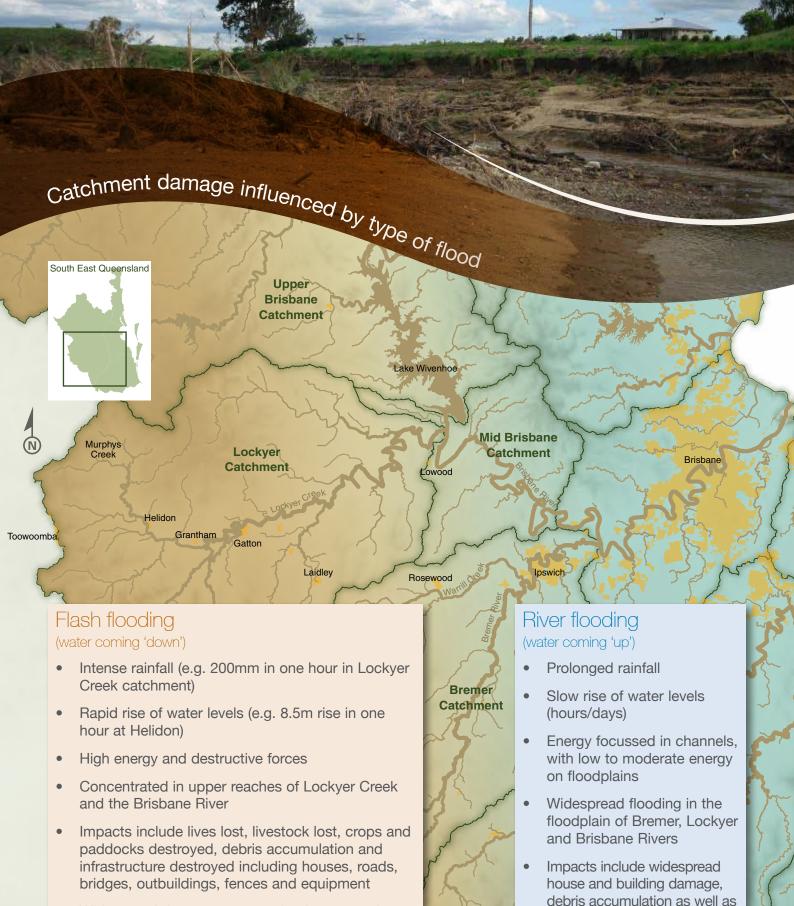
Streambank collapse has occurred along many kilometres of the waterways, as evidenced by bare and near-vertical streambanks, and areas of slumping. The collapse and slumping is a direct result of the physical action of flood waters scouring out the base of the streambanks, with large sections becoming unstable and toppling into the stream.

Streambank erosion in the Brisbane River upstream of Moggill (top) and streambank collapse in Lockyer Creek at Lockyer Siding (bottom).
