Pipe Creek Report Card

Firelands Coastal Tributaries Watersheds

Pipe Creek 2012 Report Card

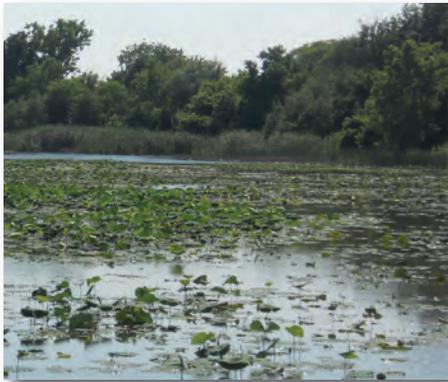
A key feature of Pipe Creek is the wetlands in both the creek and estuary areas.

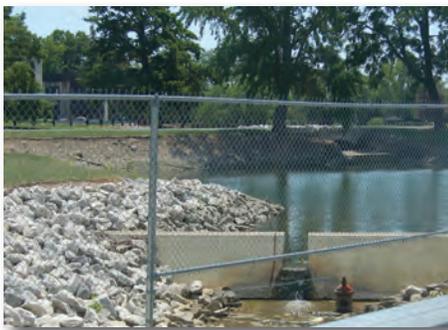
In many urbanized areas, Pipe Creek has been modified and controlled.

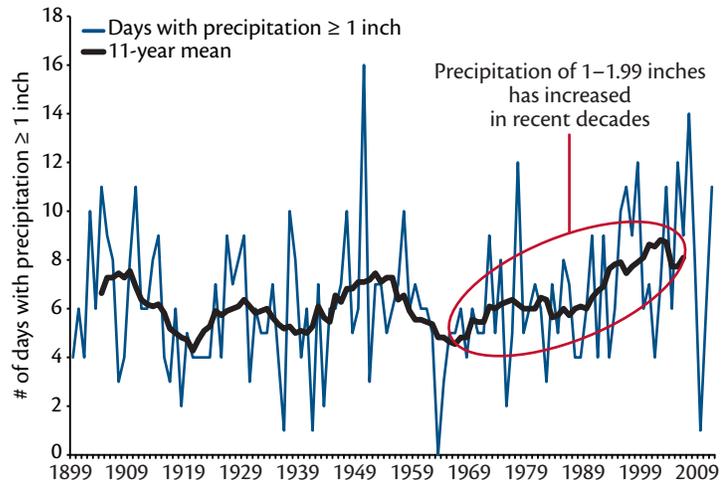
Over the last few decades, this region has experienced an increase in the number of days per year with precipitation measuring at least one inch (figure). Despite observed increases in storm intensity, in 2012, Pipe Creek experienced drought-like conditions in the summer months. Drought conditions began to develop in north-central Ohio in early summer, according to the U.S. Drought Monitor, and reached peak intensity in July and early August. Because Pipe Creek, like many watersheds, is a storm-driven system, water quality responds to storm activity for the year. 2011 was a very wet year, resulting in poor water quality in samples analyzed. In 2012, there was slightly better water quality, due to the lack of storms, not because of improving land stewardship.

Historical records show the overall trend of increasing 1–1.99 inch storms in the last 40 years.

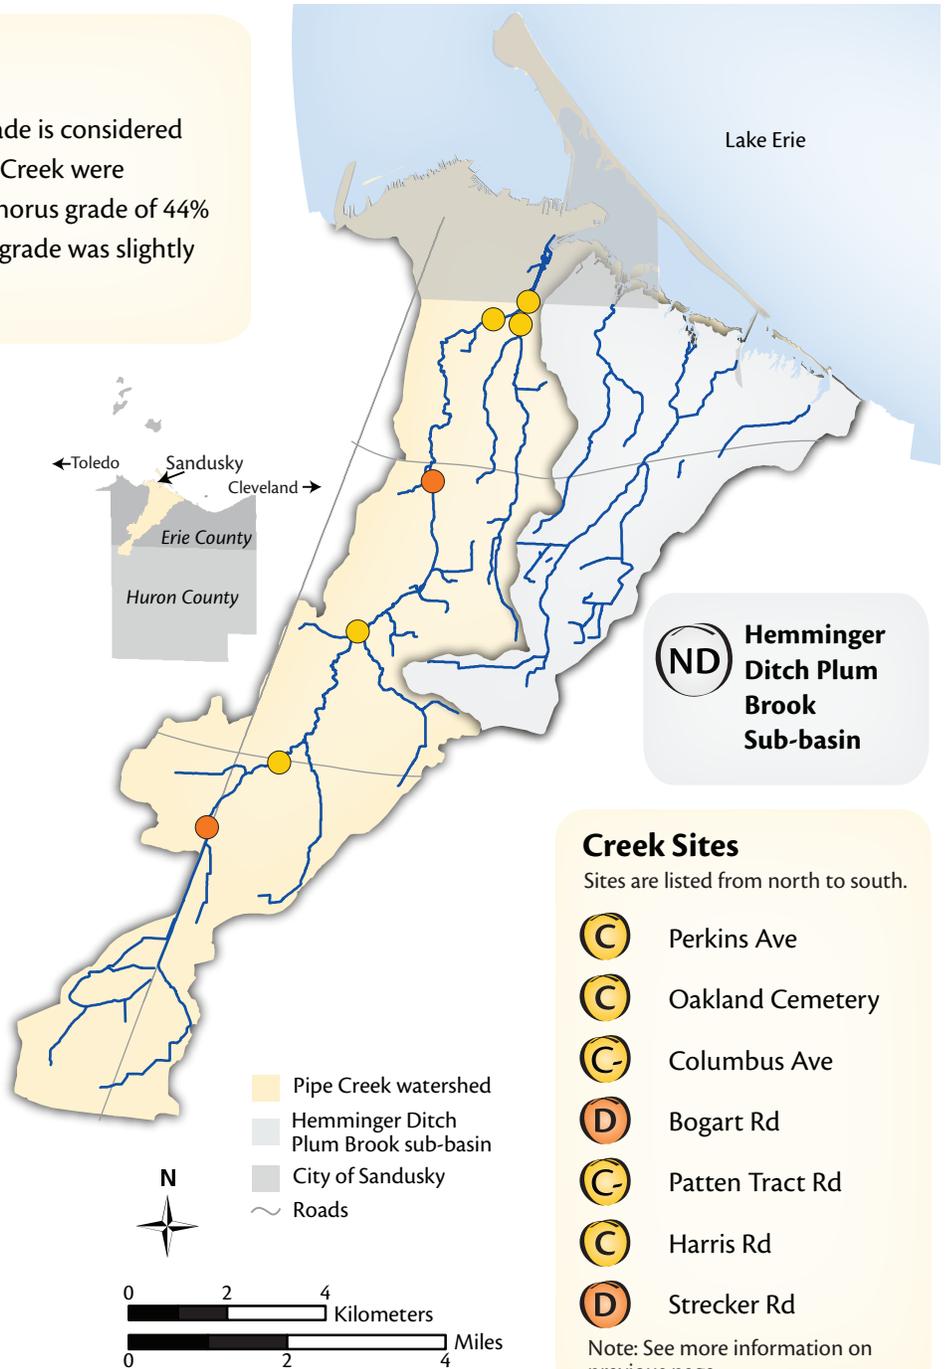
Creek Sites

Pipe creek scored a 42% for 2012. This grade is considered moderately poor. Nutrient scores in Pipe Creek were moderately poor and poor, with a phosphorus grade of 44% and a nitrate grade of 30%. The turbidity grade was slightly better at 54%, a moderate score.

Sites are listed from north to south.

- (C)** Perkins Ave
- (C)** Oakland Cemetery
- (C)** Columbus Ave
- (D)** Bogart Rd
- (C)** Patten Tract Rd
- (C)** Harris Rd
- (D)** Strecker Rd

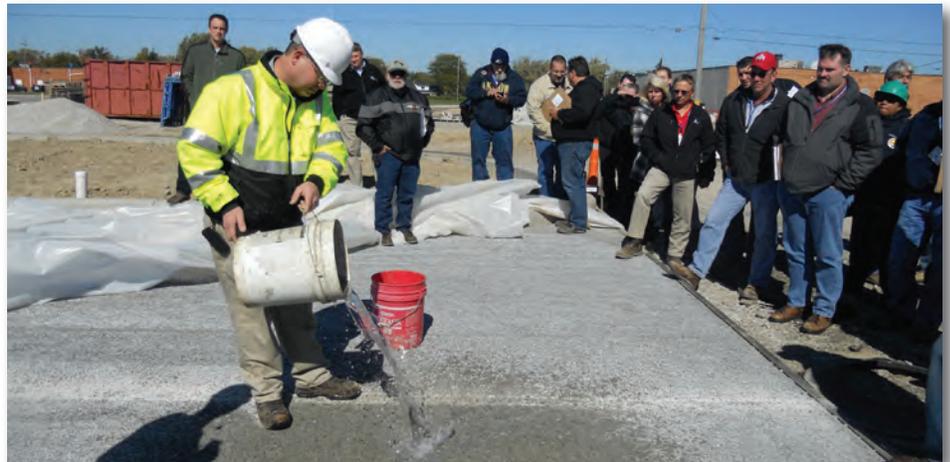
The new Perkins Township Administration Building is a great example of LID in action. As part of the redevelopment plan, runoff was reduced by installing pervious concrete in the building's parking stalls. Pervious pavement

A demonstration shows the infiltration of newly installed porous pavement at the Perkins Township Administration Building.

provides an area to collect and infiltrate stormwater, which reduces runoff effects such as downstream flooding and water pollution. Perkins Township is “paving

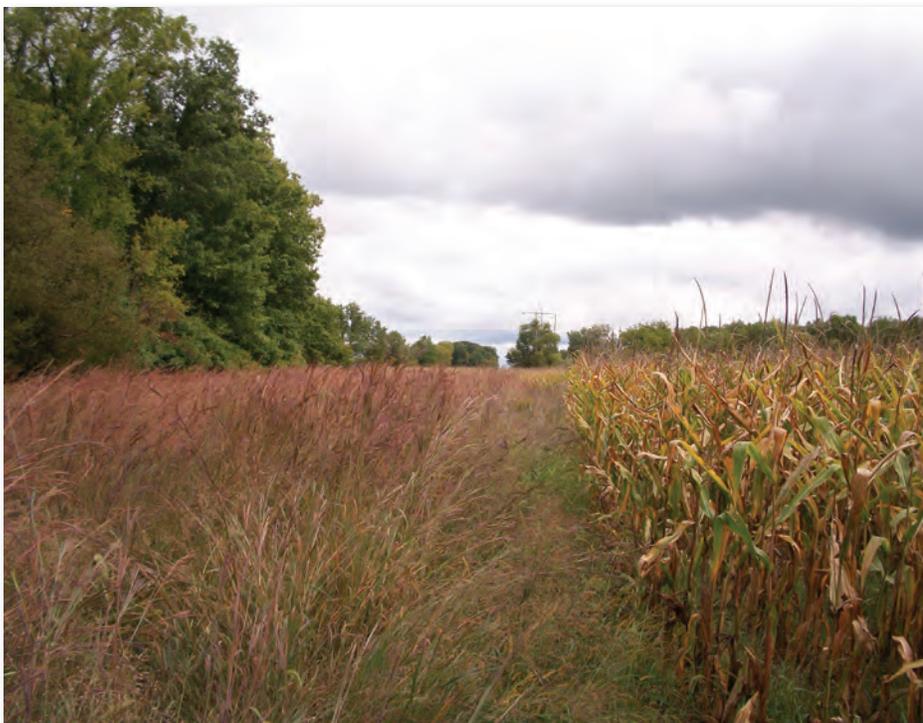
Grass buffers along farm fields keep sediment and nutrients from entering Pipe Creek.

Compared to other watersheds in Erie County, Pipe Creek has the highest percentage of natural grass buffers on farm land through the Conservation Reserve Enhancement Program. These buffers help protect over 3.3 miles of stream from sediment entering the creek. Agricultural conservation is good for Lake Erie and is profitable for the farmer.
