DEVELOPING A CHESAPEAKE BAY REPORT CARD

Adrian Jones¹, Bill Dennison¹, Francis Pantus² and Jane Thomas^{1*}

¹ Integration and Application Network, University of Maryland Center for Environmental Science, PO Box 775, Cambridge MD 21613, USA

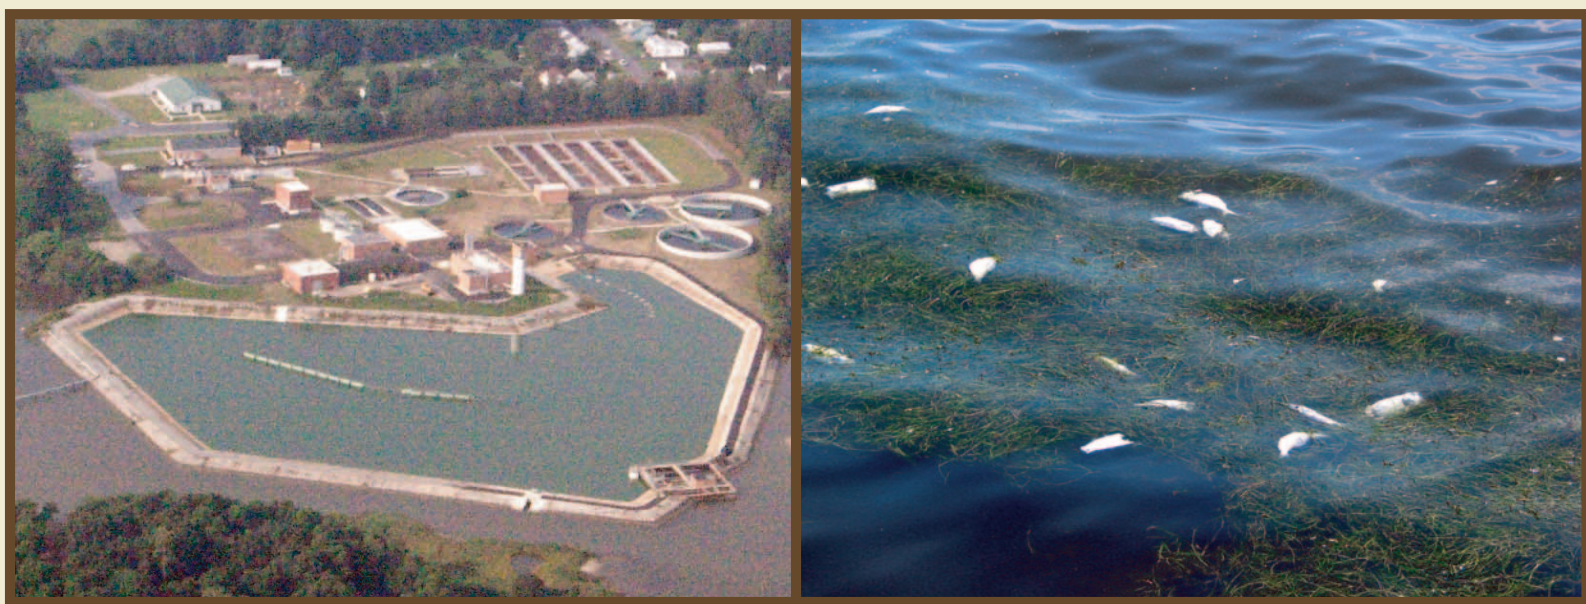
Cambridge wastewater treatment plant. Sewage effluent has a high $\delta^{15}\text{N}$ signature which can be detected by analyzing organisms incubated in the area.

Fish kills were a common occurrence during sampling in July 2003, associated with toxic algal blooms and periods of hypoxia/anoxia.

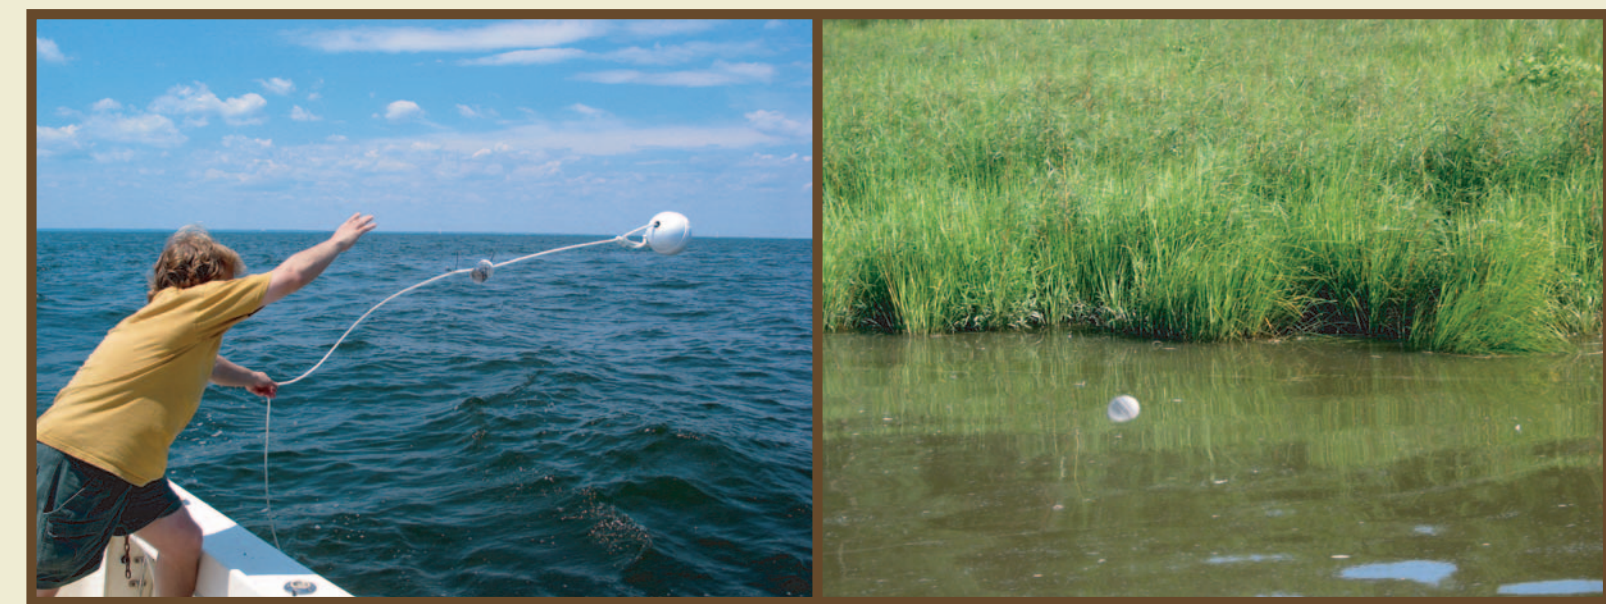
Deploying the incubation rig with buoy, perforated macroalgal chamber, sinker and bricks.

Incubation chamber deployed in the upper Choptank River.
