# Old Woman Creek Report Card

# Firelands Coastal Tributaries Watersheds

# Old Woman Creek 2012 Report Card

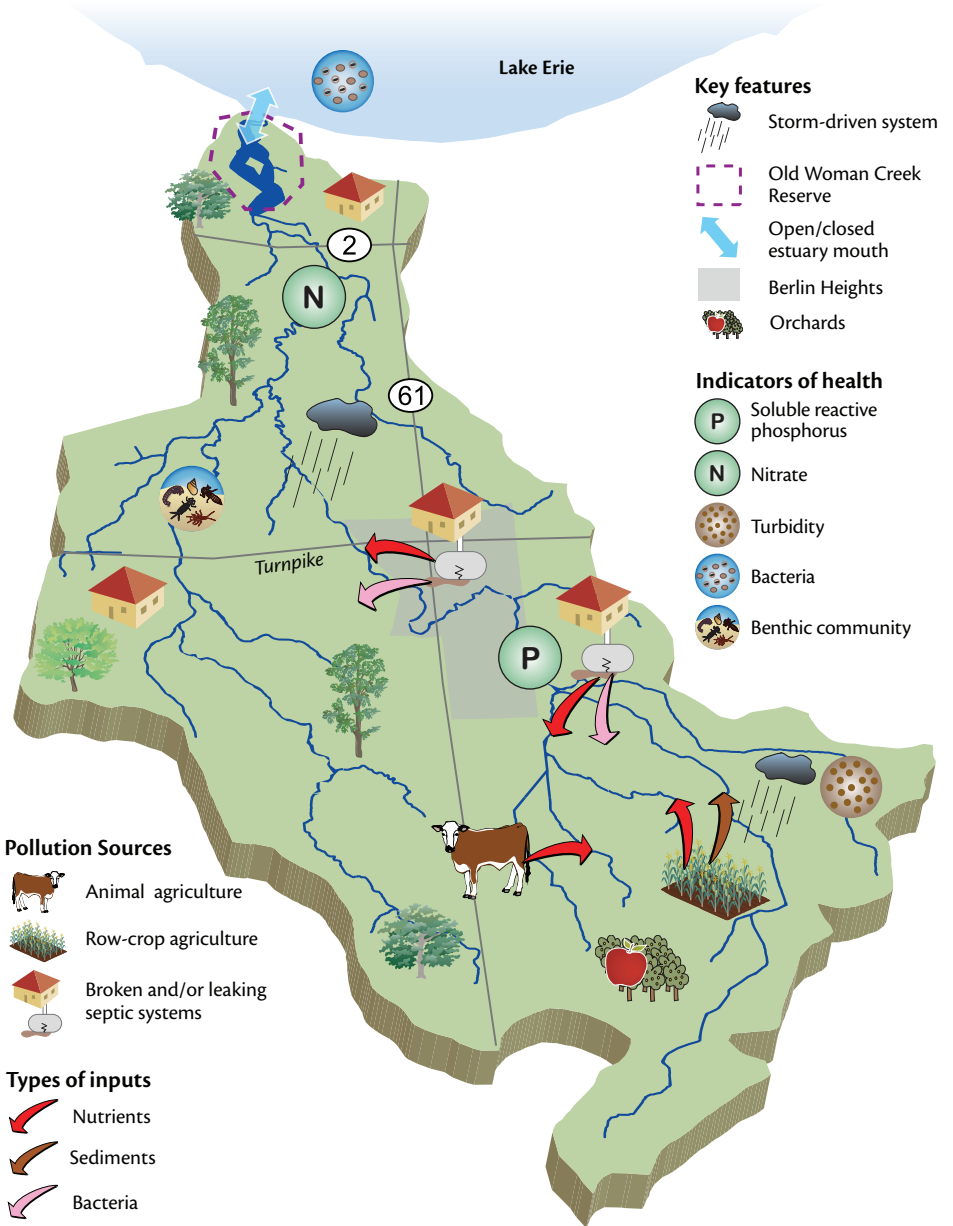
Great Lakes freshwater estuaries are partially enclosed coastal wetlands found where creeks or rivers meet, mix, and interact with the lakes. A unique feature of Old Woman Creek is the estuary mouth, which can be open or closed.

Old Woman Creek estuary is isolated from the lake by a barrier beach that opens and closes according to stream flow and lake wave action. When the mouth is closed, water accumulates in the estuary, allowing wetland processes to filter out pollutants. The Old Woman Creek estuary is one of the best examples of an intact coastal wetland in the Lake Erie watershed. However, like the lake, the estuary is impacted by natural

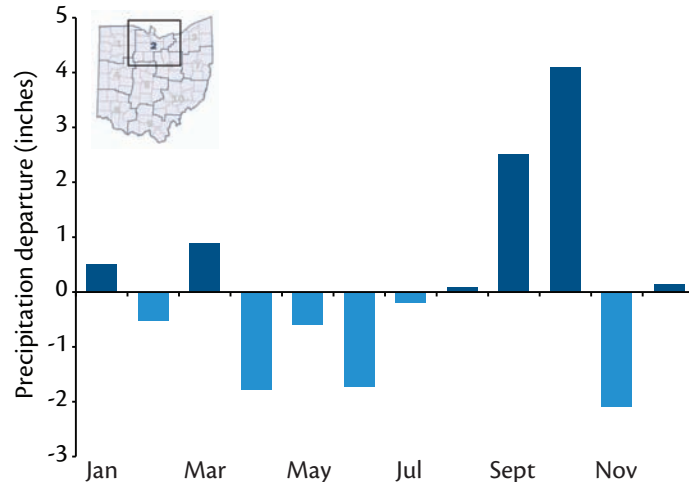
In 2012, rainfall was low or below normal for the first half of the year in north-central Ohio (inset map), then increased dramatically due to the effects of Hurricane Sandy.

In 2012, Old Woman Creek experienced drought-like conditions in summer; however, precipitation totals were near normal by the end of the year. Throughout the year, there was a mix of months with either above or below normal precipitation (figure). Drought conditions began to develop in north-central Ohio in early summer, according to the U.S. Drought Monitor, and reached peak intensity in July and early August. Above normal precipitation from August to October helped eradicate drought conditions by the end of the year. October precipitation was especially above normal, with north-central Ohio averaging 6.5 inches during the month (4.09 inches above normal), mainly due to the effects of Hurricane Sandy.

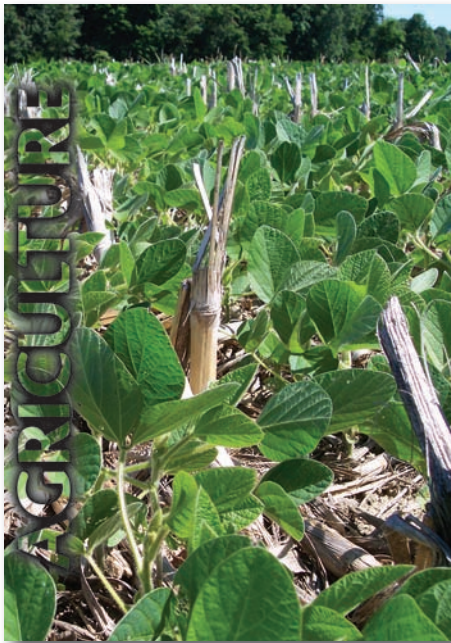
*Best management practices, such as no-till farming, are being used within the watershed.*

Local farmers work with the Erie Soil and Water Conservation District and the Natural Resource Conservation Service to address nutrient and sediment loss impacting our local streams. Many Old Woman Creek farmers have adopted conservation practices such as “no-till” to reduce field erosion. In addition, some farmers also maintain natural wooded buffers between the stream and farm fields. These buffers help prevent polluted runoff from entering the stream and improve stream function to remove pollutants entering upstream. Good soil health is essential for growing healthy crops and preventing water quality issues. As farmers continue to improve the soil on their farms, water quality will also improve in our streams and Lake.

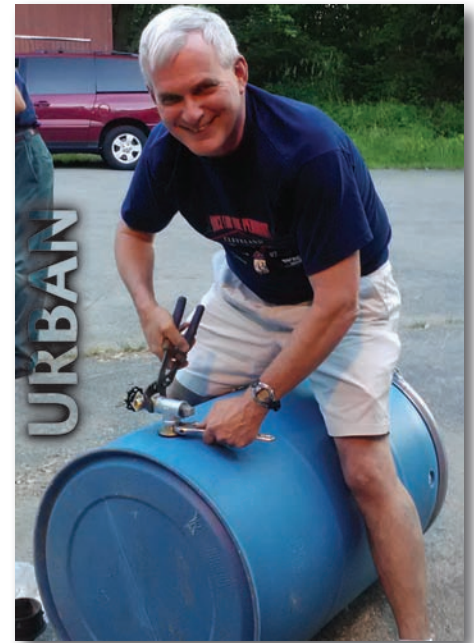
*Rain barrels can be installed to gather and store rainwater, which can then be used to water gardens.*

Old Woman Creek Research Reserve is a watershed model of sustainability that educates others about stormwater management. In 2009, the Reserve planted a rain garden at its visitor center, the first demonstration of low impact development in Erie County. The rain garden helped address flooding issues and provides an educational opportunity for visitors. Public officials, professionals, and watershed groups have benefited from Reserve training and research that helps them effectively manage runoff. Rain barrel workshops offered in partnership with the Firelands Coastal Tributaries Watershed Program have educated residents on the importance of rainwater collection and assisted them in building over 400 rain barrels that capture 20,000 gallons of water during each storm.
