ANTIETAM CREEK WATERSHED REPORT CARD 2025

ANTIETAM CREEK AND BEAVER CREEK

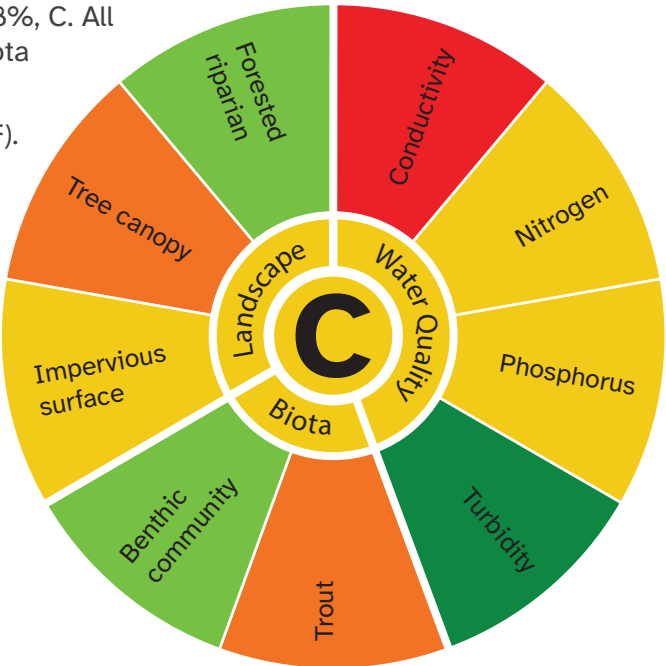
The Antietam Creek Watershed is in moderate condition, scoring 48%, C. All categories had C grades; Water Quality scored 52%, followed by Biota (47%) and Landscape (45%).

The lowest-scoring Water Quality indicator was Conductivity (18%, F). Moderate Nitrogen (42%, C-) and Phosphorus scores (56%, C+) suggest there was nutrient loading in the creek. However, Turbidity received a very good score (91%, A), which shows that the water was clear.

For the Biotic grade, indicators included the abundance and diversity of the Benthic community, and the presence and year classes of two Trout species, Rainbow and Brown. The Benthic community was in good condition, scoring a B- (64%). However, the Trout community was in poor condition with a D score (30%).

Landscape indicators assessed the land cover in the watershed and along creeks. A poor Tree canopy score (31%, D) and moderate Impervious surface score (42%, C-) show development pressure negatively impacting the watershed. Forested riparian was in good condition (63%, B-), meaning that there are buffers between development and creeks.

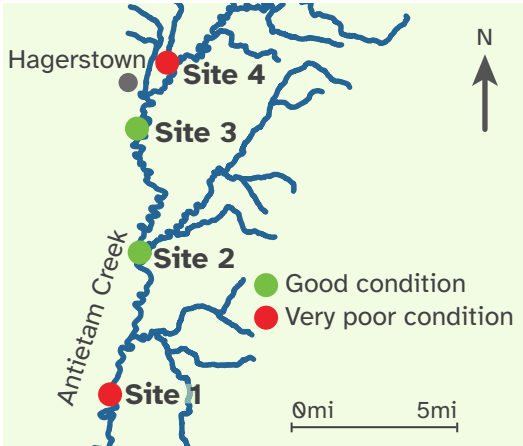
Bacteria sample sites on Antietam Creek.

Bacteria are everywhere in our environment, but some bacteria can make water unsafe for contact. *E. coli* is used as an indicator of possible harmful bacteria in the water. High numbers of *E. coli* represent an increased risk to humans of becoming sick after coming in contact with the water. In Antietam Creek, bacteria was high at Sites 1 and 4. Site 1 in particular consistently measured bacteria levels over the safe threshold (235 MPN), meaning the conditions were very poor.
