Patapsco River

2024 Report Card

The Patapsco River is in moderate condition

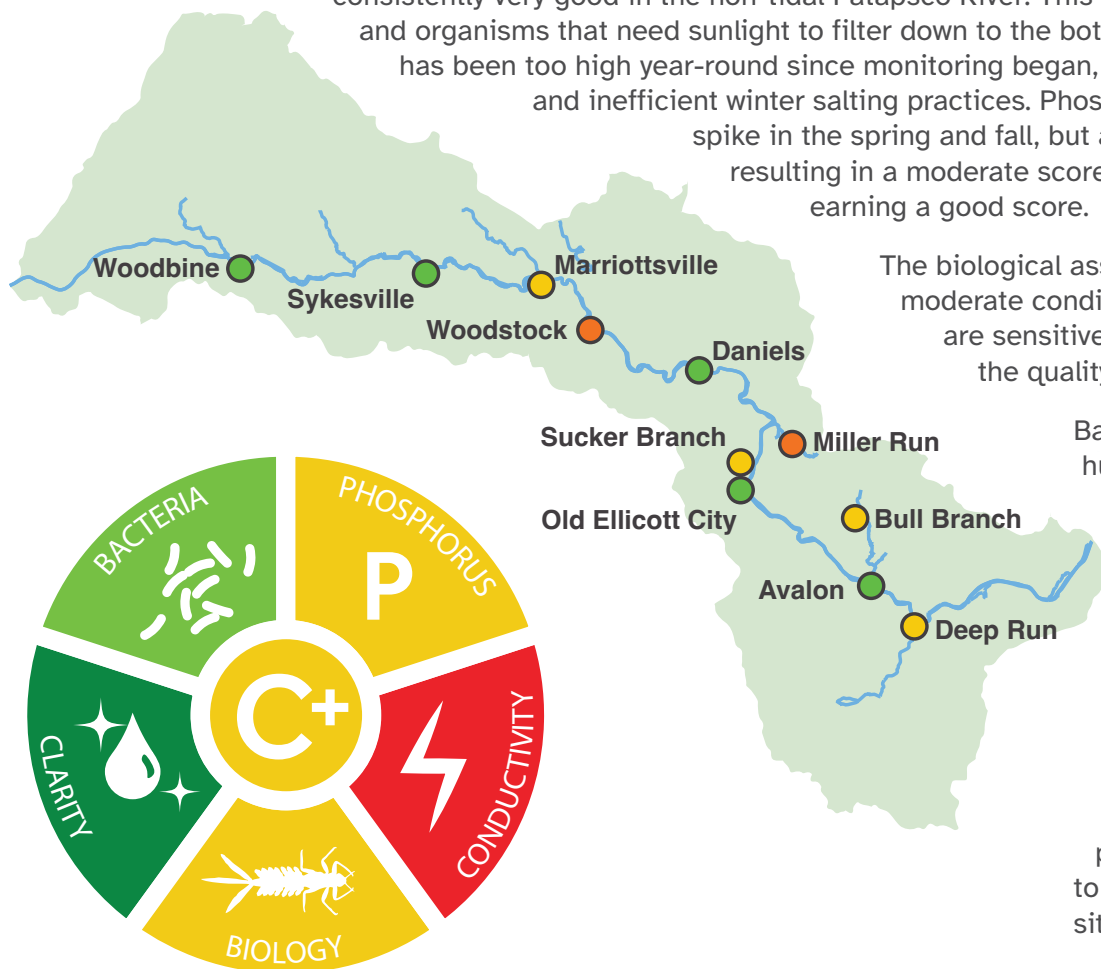
The biological assessment shows that the river is in moderate condition. Benthic macroinvertebrates are sensitive to pollution and therefore reflect the quality of the river as a suitable habitat.

Baseflow contributions to the river, human use and development, and pollution inputs can all vary considerably from station to station. Some pollutants accumulate downstream, but others settle to the bottom and stay in place. This may explain why the tributary sites, Sucker Branch, Bull Branch, Miller Run, and Deep Run, have higher readings of conductivity, phosphorus, and bacteria, and tend to score lower than the main stem sites each year.

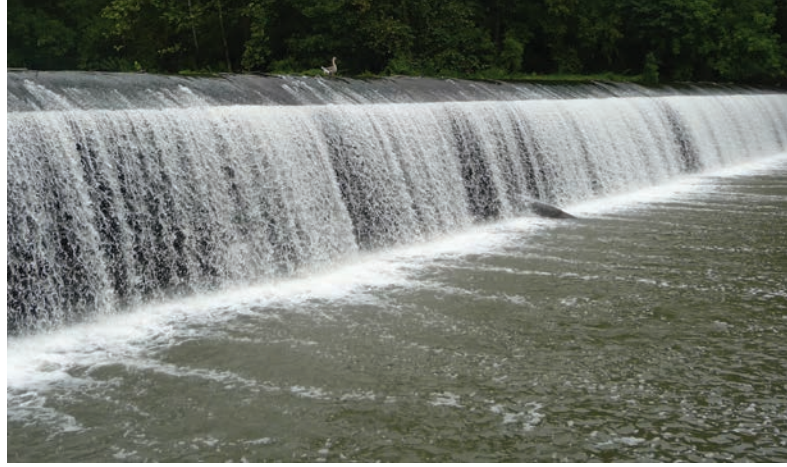
In the past, many dams harnessed the power of the Patapsco River to run mills and generate electricity. Daniels Dam once provided horsepower for now-destroyed canvas mills and generated surplus electricity for BG&E. Daniels Dam is the last remaining dam on the mainstem of the non-tidal Patapsco River. The dam is aging and requires costly repairs to safely remain in place.

The Maryland Department of Natural Resources is evaluating the future of the dam and surrounding area. The study will consider whether or not to remove the dam. Removal of other dams along the Patapsco has improved ecosystem health and restored access to natural habitats. Removing this dam increases river connectivity for migrating fish like shad and eels. Public input for the study is important; contribute your thoughts by emailing DanielsDamOutreach@AmericanRivers.org.
