Laguna de Bay 2013 Ecosystem Health Report Card

Laguna de Bay, a special ecosystem

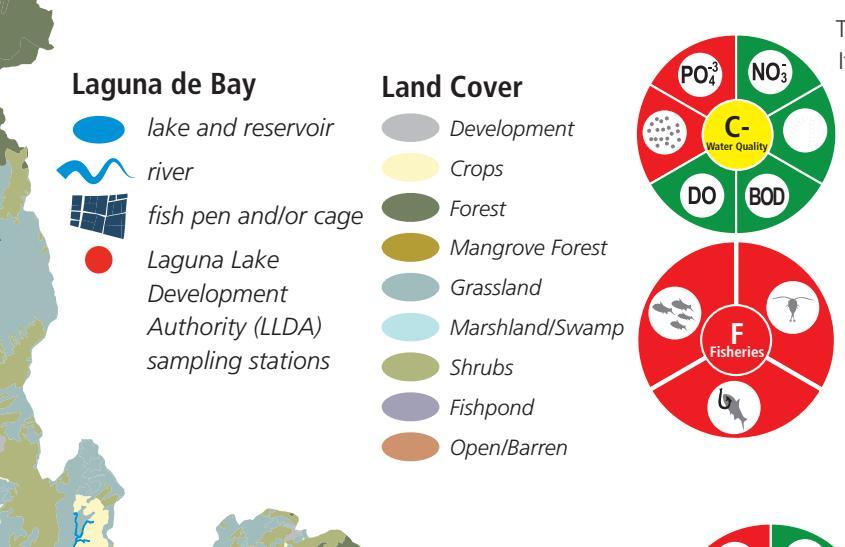
The West Bay has the second lowest water quality score, 76%. It is the most heavily developed side of Laguna de Bay and most populated. For 2013, its DO, BOD and nitrate were within DENR's guideline for class C waters (100%) and its total coliforms at 98%. However it has the second lowest score in phosphates (56%) and like all the bays, received a 0% in chlorophyll *a*. This scores reflect its high population density and the need to reduce phosphorus runoff into the Lake.

The Central Bay has the lowest water quality score at 71%, however, its 65% score in Fisheries is the highest of all bays. Although it scored 100% in nitrate, DO, BOD, and total coliforms, it had the lowest score in phosphates with 25%, and a 0% in chlorophyll a.

The East Bay has the highest water quality score at 81%. It received an A in all water quaity indicators except for chlorophyll *a* (0%, an F). However, the East Bay scored the lowest in fisheries with 28%, scoring a mere 3% for CPUE.

The South Bay has the second highest score in water quality at 77%, with 100% in nitrates, DO, BOD, and total coliforms. Like all the bays, it has a 0% in chlorophyll *a* and an F in phosphates at 63%. It had the second lowest score in fisheries, 43%, with the lowest score in native fish species composition at 37% even though a designated fish sanctuary is located within the South Bay.

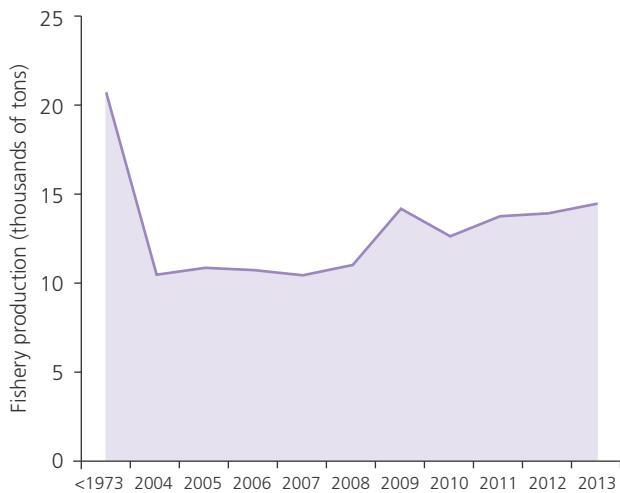
Ten year production trend in Laguna de Bay. Data source: Bureau of Agricultural Statistics

Fisheries production prior to the introduction of fish pens in 1973 was at 20,700 ton per year (T/yr) Catch data in 1995 was at 8,146 T/yr before the reported sightings of invasive species. In 1996, catch was at 3,055 T/yr when there were two strong typhoons and catch data were most likely from natural recruitment.

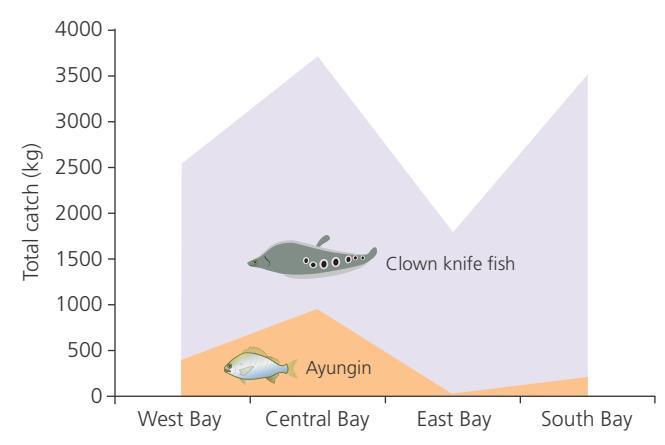
Comparison of clown knife fish and ayungin catch from actual sampling in Laguna de Bay in 2013. Data source: Bureau of Fisheries and Aquatic Resources (BFAR)

One of the most important native fishes in the Lake is the ayungin (*Leipotherapon plumbeus*). The highest total catch in 2013 is in the Central Bay, while the lowest is in the East Bay. This can be attributed to the high concentration of the invasive clown knife fish (*Notopterus chitala*) in the East Bay, which prey on ayungin. Clown knife fish eggs also attach to cultured fish cages and pens and once hatched, will feed on the fry and fingerlings of big head carp and bangus. The proliferation of knife fish has caused significant declines in cultured and native fish production.

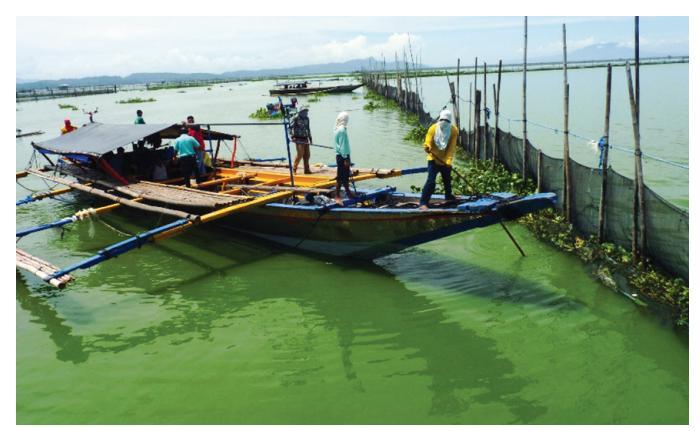
Algal bloom in tilapia fish pens. Photo: Mark Anthony Salvador

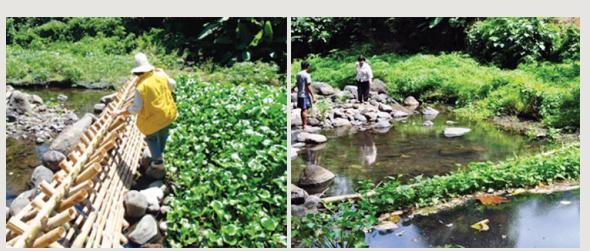
Molawin Creek is declared a biopark as water quality improves using AMBS. Photos: Dr. Macrina Zafaralla (Los Baños Times)

A simple, cost-effective filtration system is a promising solution to pollution, fish production, and biodiversity problems in Laguna de Bay. It is centered on the University of the Philippines (UPLB) Los Baños' phytoremediation system called the UPLB Aquatic Macrophyte Biosorption System (AMBS). It aims to restore degraded water quality of Laguna de Bay tributaries.

The AMBS system is made of bamboo and water hyacinth (*Eichhornia crassipes*) or kang kong (*Ipomoea aquatica*). Initial data showed visible evidence of habitat restoration, i.e., clearer water after filtration and robust populations of native fish fingerlings in 1–2 weeks. Community cooperation is developed through stream clean-up before installation.
